ABBREVIATED PROPERTY

CONDITION REPORT

Description: Multi-Tenant Retail Center

Date of Walk-Through: 02/08/2018

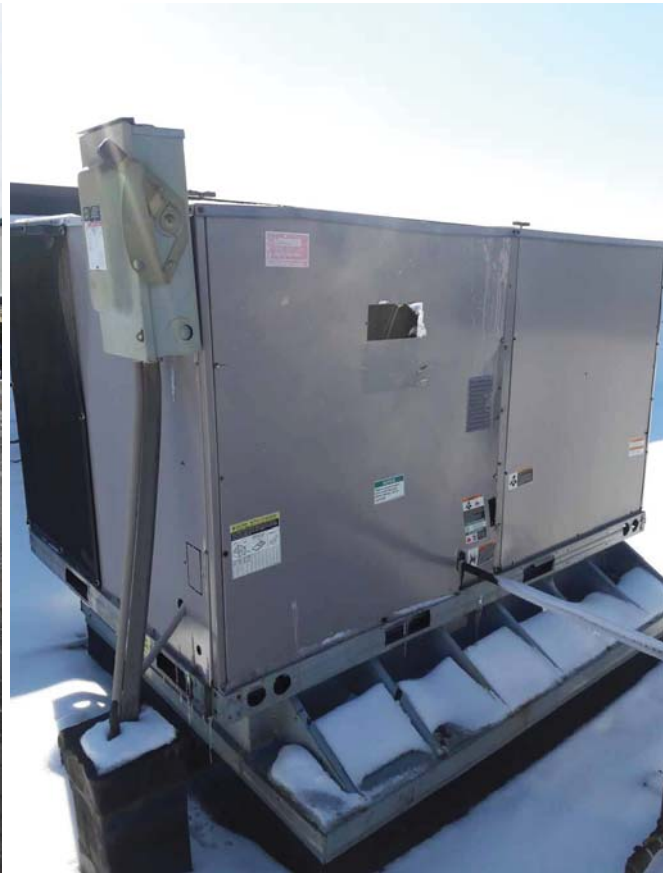
RTU above/serving the laundromat below

Similar to the electrical system, once again it bears repeating that an accurate overall assessment of the HVAC system by simply conducting a cursory walk-through of the premises is next to impossible. This added to adverse weather conditions—namely a snow covered roof accompanied by cold, freezing weather—on the day of the walk-through not to mention the lack of a mechanical equipment schedule available for review before, during or subsequent to the walk-through, we essentially have little if any information to work with for rendering much less substantiating an opinion in regard to the serviceable condition of the mechanical rooftop equipment serving the entire multi-tenant retail center. While the lack of information regarding the mechanical heating and cooling system alone serves to increase the risk of purchase, a cursory inspection of a package rooftop unit located above/serving the laundromat below left much to be desired in regard to the care and maintenance thereof.

Further professional evaluation/investigation above suspended tile ceiling systems inside/serving tenant spaces that have been prone to roof leaks in order to verify the presence/absence of rust degradation to the metal roof decking above.	
Anticipate replacement of older/aging package rooftop units in the 15-20 year plus range (Budget cost based upon 80% of an estimated 400 tons of cooling or 320 tons of cooling at a unit cost of \$1,000 to \$1,500 per ton). ⁴	\$320,000 to \$480,000
Consult with a qualified, licensed mechanical contractor for determining age, model and serial numbers, and size of each and every package rooftop unit to facilitate the preparation of a more accurate budget cost for the future repair/replacement thereof.	
Consider professional evaluation by a qualified, licensed electrical contractor of the entire electrical system b4 closing including an infrared scan of all older electrical supply and power distribution equipment to check for the presence/absence of hot spots.	Obtain Quote
