ROOF INSPECTION REPORT  
PREPARED EXCLUSIVELY  
FOR

**Description:** Restaurant Bar & Grill

**Date/s of Inspection:** 01/24/2015

**Date of Report:** January 28, 2015

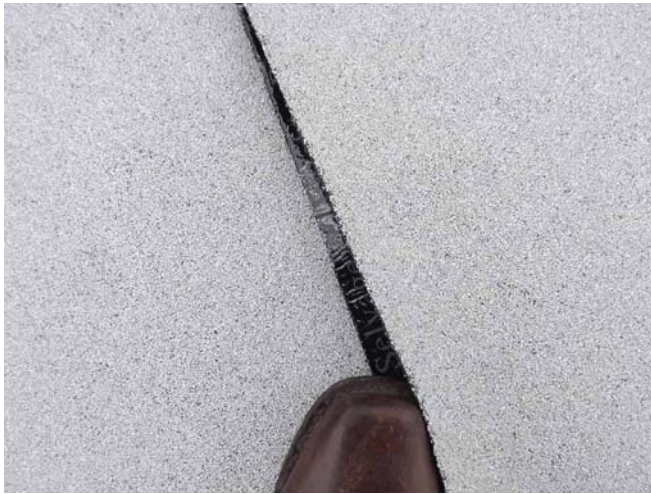
Open/unsealed sidelap

- ◆ Open/unsealed sidelap in modified bitumen roofing in close proximity to/just north of package rooftop unit #5 due to plastic selvage edge release strip left in-place that prevents bonding.

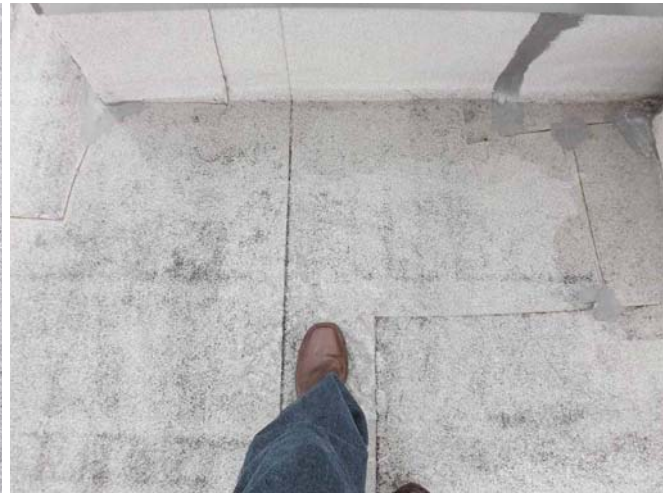
Standing water present outside the elevator shaft

- ◆ Significant standing water present in/around the vicinity of the roof drain opening, elevator shaft roof penetration, and elsewhere on the roof that have already resulted in roof leaks.

† **Note:** Excludes cost to provide for an additional interior roof drain as may be required along with overflow scuppers to ensure positive drainage and alleviate standing water on the roof.

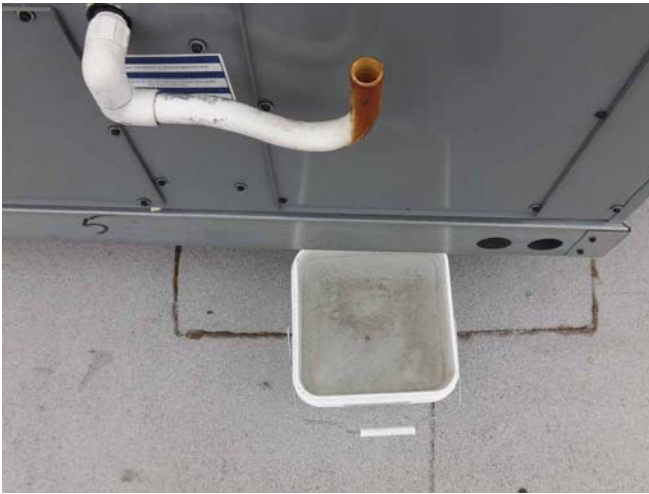
Bucket w/ice water from condensate drain line above

- ◆ Condensate drain lines (serving package rooftop units) that allow for condensate to drain directly onto the roof as opposed to a gutter or open drain per roof manufacturer's recommendation.

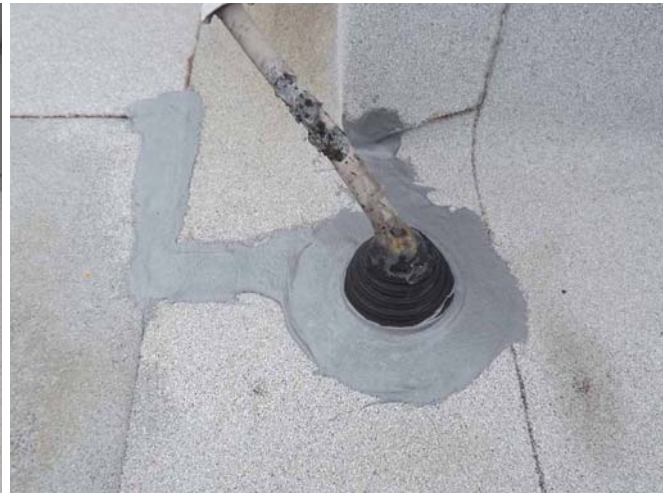
- ◆ Gray sealant applied along sidelap joints and small roof penetrations in what appears to be an after thought to compensate for poor bonding at these areas when installing the roof system.

Sealant applied to lap joints and roof penetration

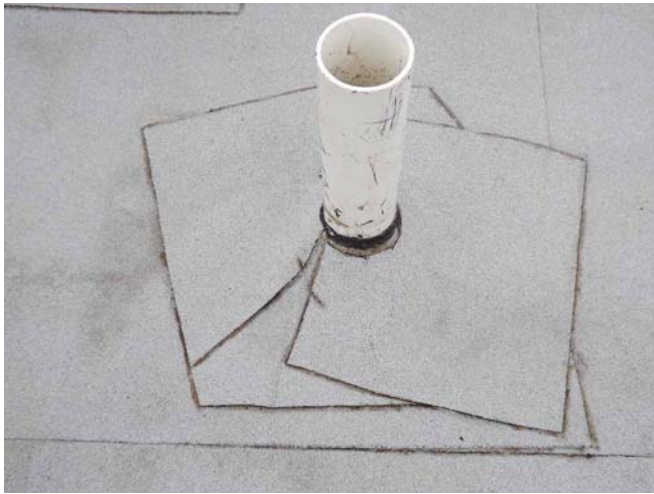
- ◆ Improper application/detail at inside corners, vent pipe roof penetrations, roof drain opening, parapet wall membrane flashing, and sheet metal coping.

Amateur/improper flashing detail at 'P' vent

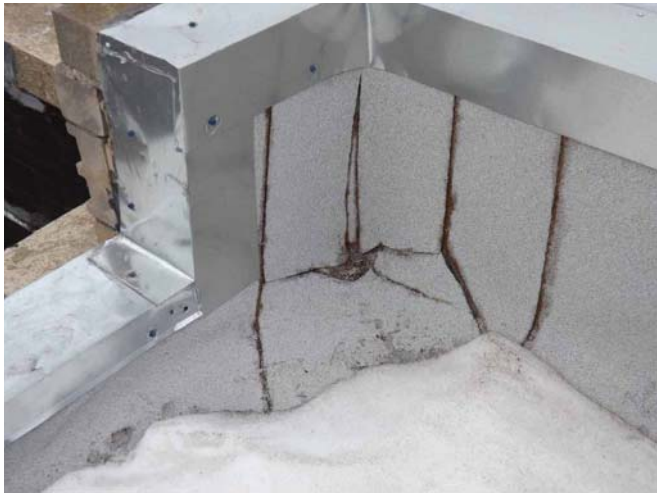
Amateur/improper wall flashing detail at inside corner
