ROOF INSPECTION REPORT  
PREPARED EXCLUSIVELY  
FOR

**Description:** Restaurant Bar & Grill

**Date/s of Inspection:** 01/24/2015

**Date of Report:** January 28, 2015

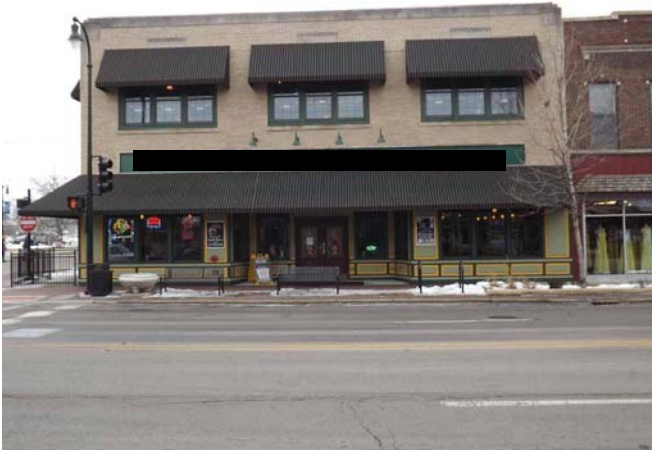
Building street elevation

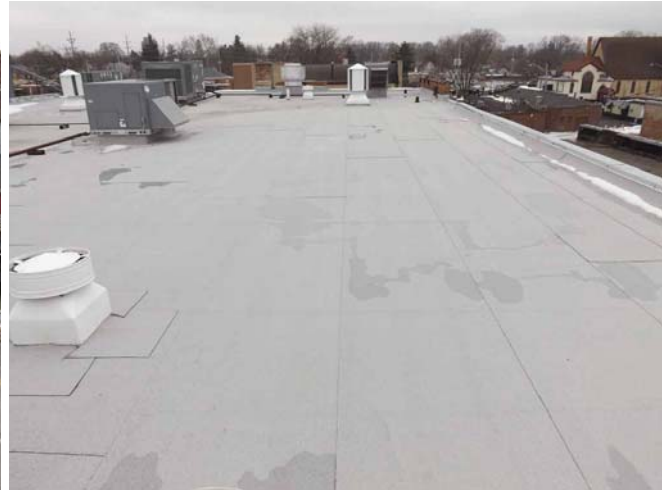
Field of MB roof above the restaurant

The Flintlastic SA modified bitumen roof system is not considered to be in serviceable condition at this time given an amateur and improper installation that repeatedly fails to conform to the requirements as set forth in the CertainTeed Flintlastic Application Handbook.

Recommendation	Budget Cost
Complete tear-off and replacement based upon 54-2/3 square @ \$600/SQ †	\$32,800 and up
